45 Cindy Lane, Adjala-Tosorontio

HYDROGEOLOGICAL ASSESSMENT

2834556 Ontario Inc.

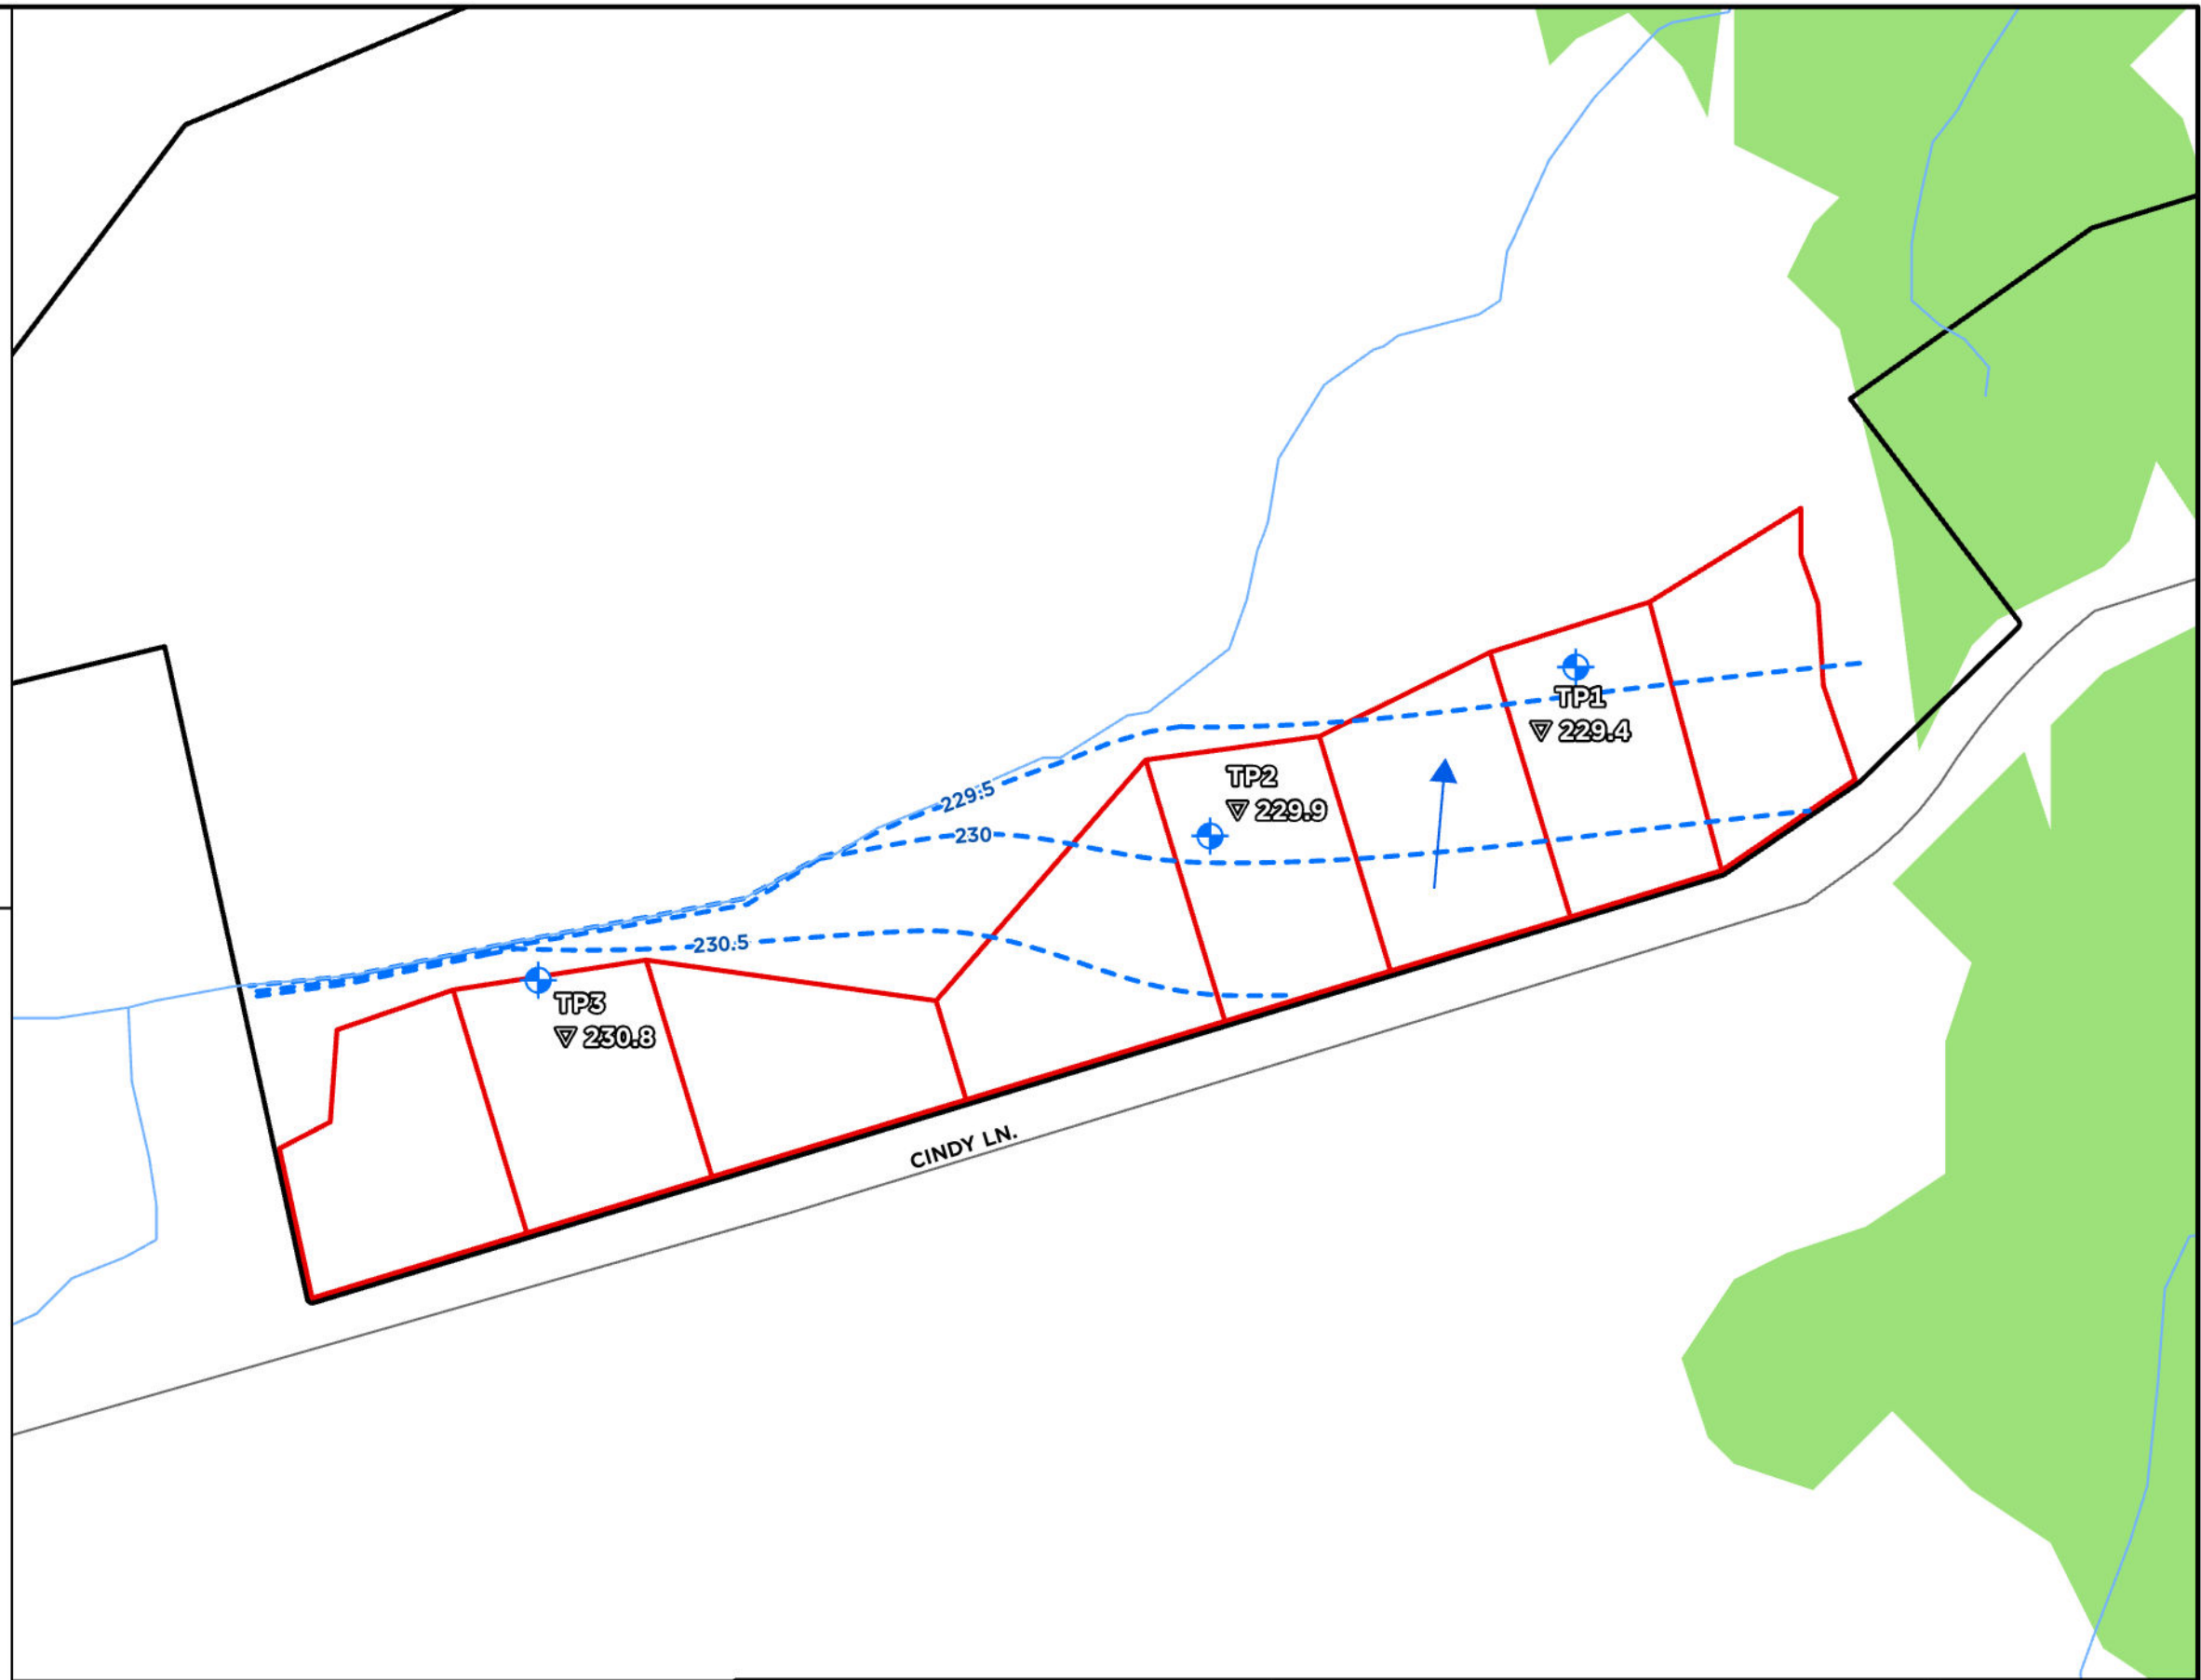
**45 CINDY LANE, ADJALA-TOSORONTIO
HYDROGEOLOGICAL SITE ASSESSMENT
SHALLOW GROUNDWATER CONTOUR**

- SITE
- SUBJECT LANDS
- TEST WELLS
- ROAD
- WATERCOURSE
- WATERBODY
- WOODED AREA
- GROUNDWATER CONTOUR
- GROUNDWATER FLOW DIRECTION
- GROUNDWATER ELEVATION (MEASURED MAY, 16, 2024)

As discussed in previous sections, the site generally consists of sandy loamy topsoil overlying layers of fine sand with trace gravel. Groundwater is expected to be encountered at depths of 0.2 to 0.5 m bgs (elevation 229.4 to 230.9). Based on the groundwater conditions observed, infiltration-based LID features (such as infiltration chambers or soakaway pits) are not considered feasible for this site as the minimum separation distance (1.0 m) between the seasonally high groundwater table and the bottom of a proposed recharge facility cannot be satisfied.
